Hybrid Approaches at Pajaro Dunes: Unique setting, thoughtful planning, better than expected outcomes

- Watsonville Slough Lagoon Restoration
- Revetment: Dune Support and Home Protection

Charles Eadie, Eadie Consultants, Santa Cruz CA

WATSONVILLE SLOUGH LAGOON RESTORATION CAP 1135 FEASIBILITY STUDY

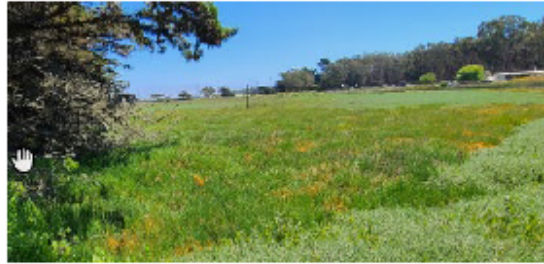
Project area includes high quality coastal wetland habitat

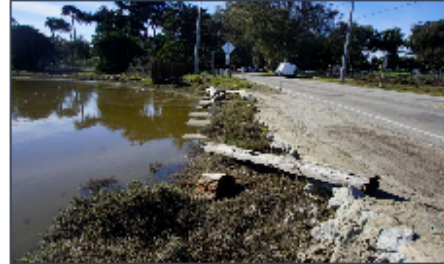
Low infrastructure

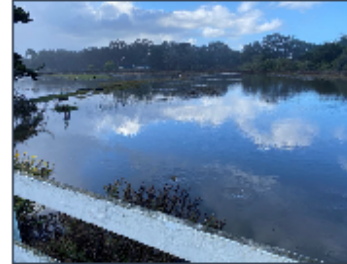
Lagoon closure + fluvial storm flow causes elevated water levels

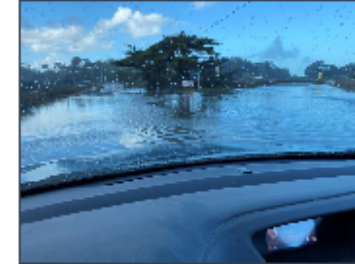
High water levels cause flooding of low elevation infrastructure (road crossings)

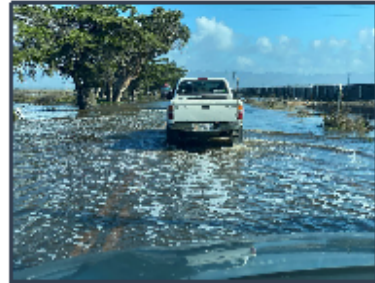
Flooding of low elevation infrastructure (road crossings) causes safety problems

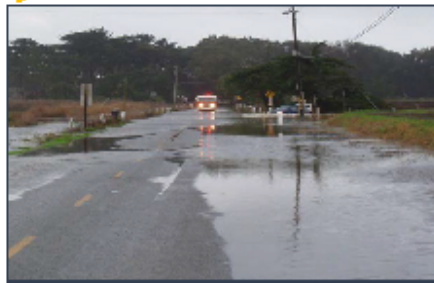
Flooding causes problems for emergency and public access

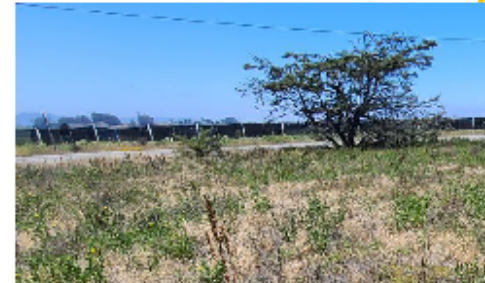
Planning hypothesis was that mechanical breaching of lagoon leaves some portions of the marsh "high and dry," a detriment to the ecosystem

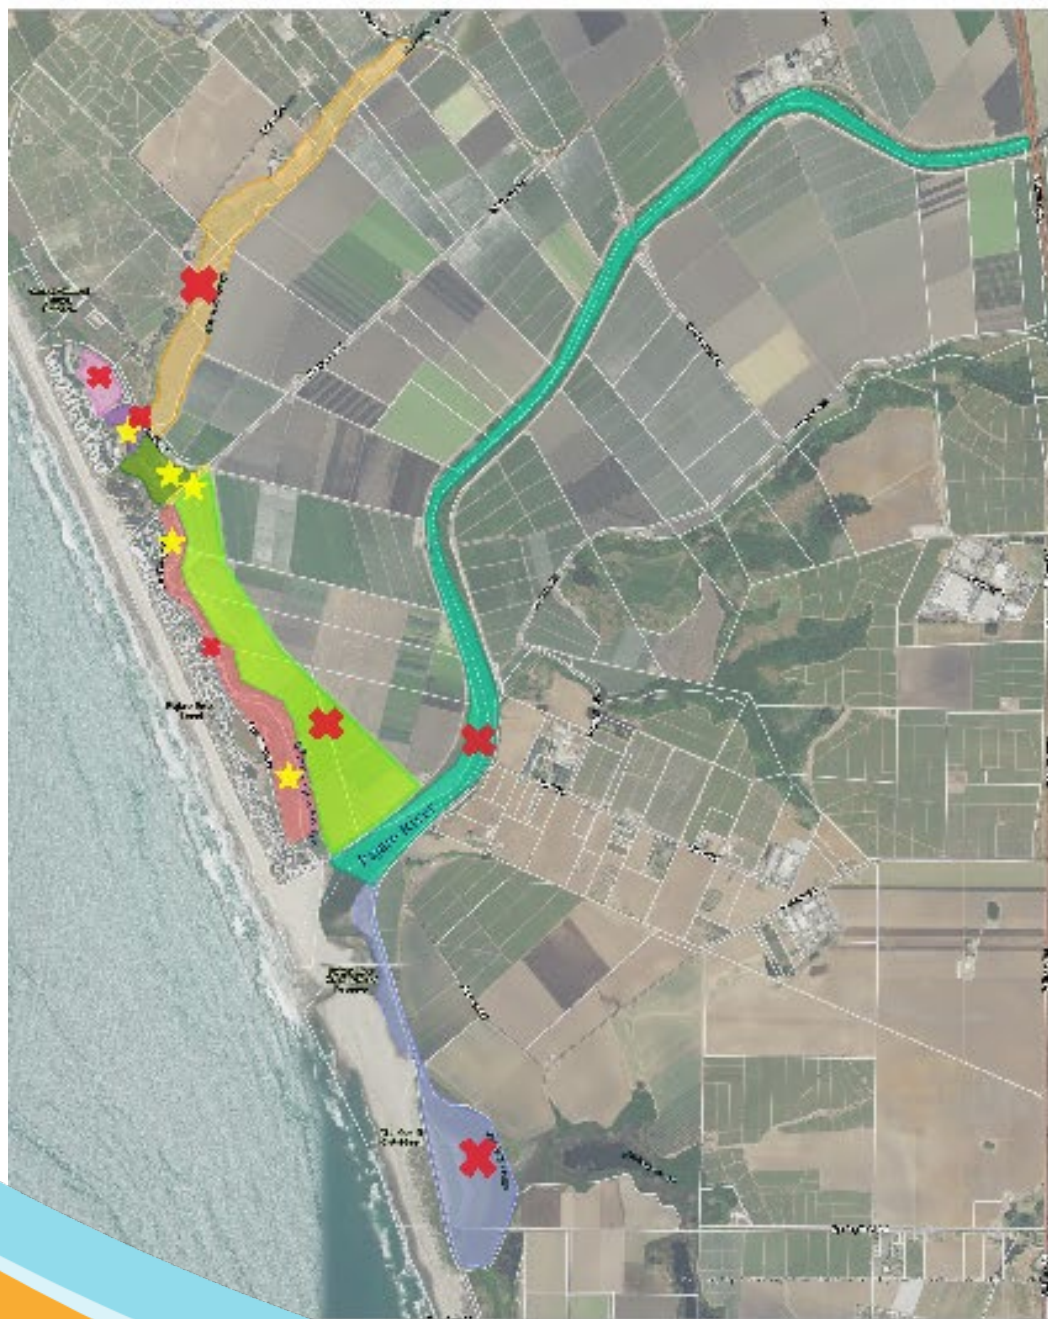
WATSONVILLE SLOUGH
Initial Arrays of
Potential Restoration
2013-2015

- Initial Array of Potential Restoration Areas
- Yellow: Agricultural Areas
 - Green: Beach and Dune
 - Purple: County Canal
 - Red: Lower Mile Beach
 - Blue: Lower Pipeline
 - Orange: Shell Road
 - Pink: Shell Road to B
 - Light Green: Shell Road to C

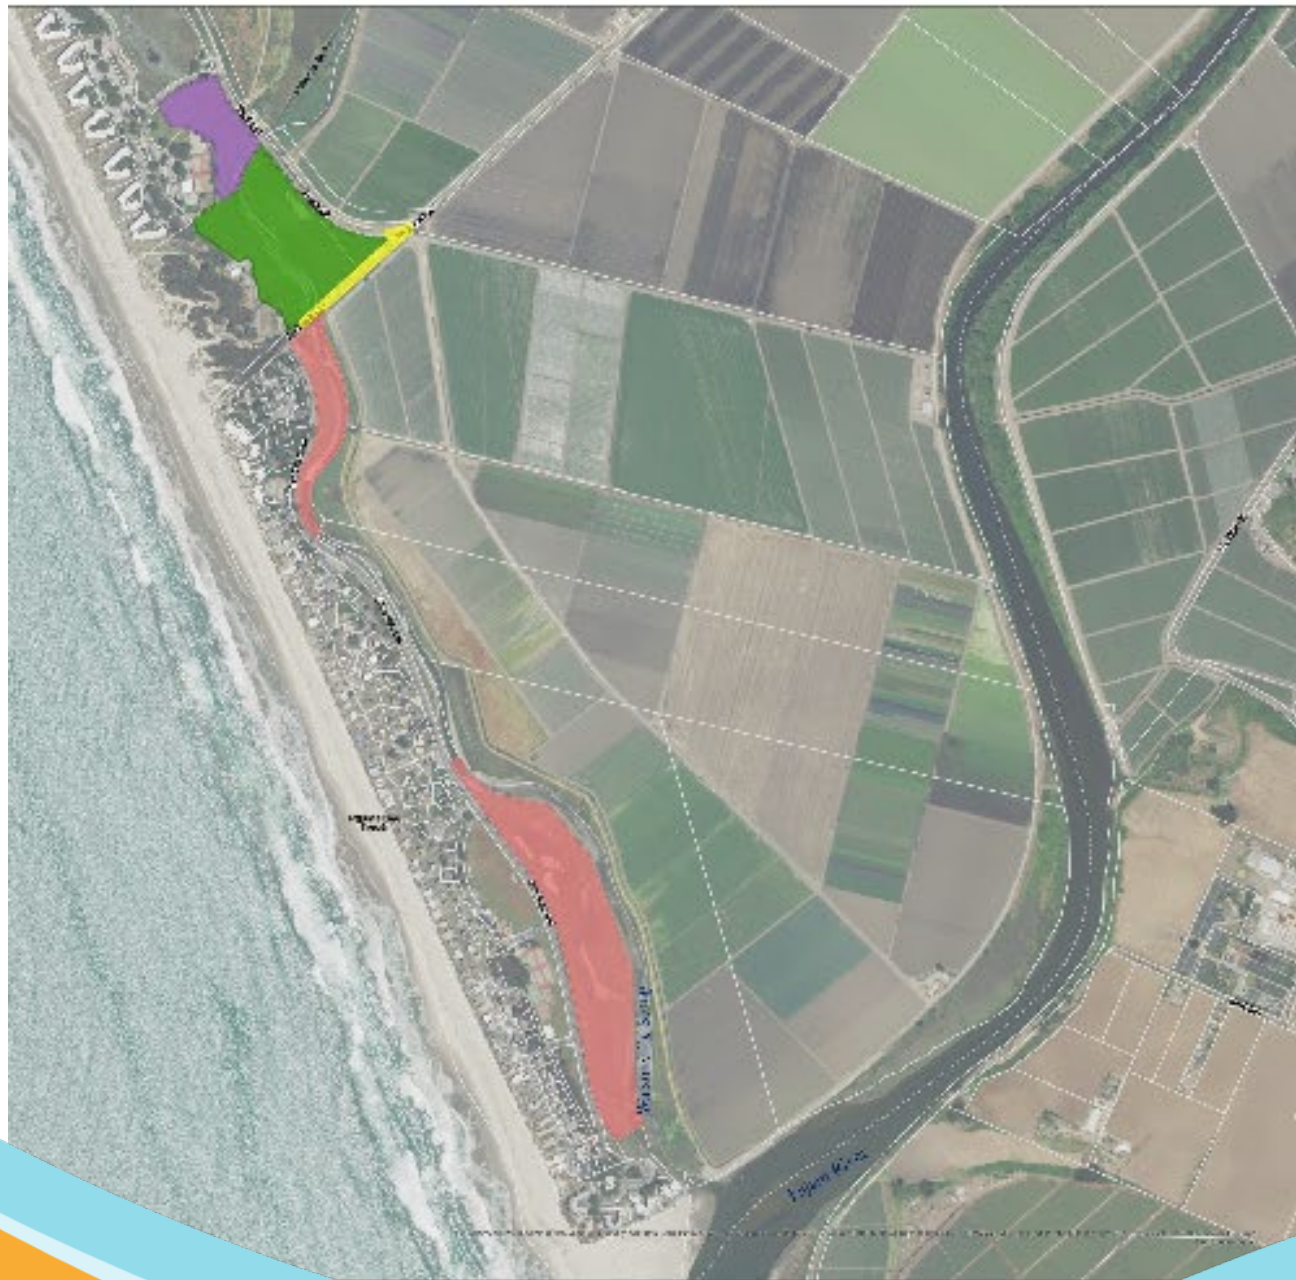
WATSONVILLE SLOUGH
 Final Arrays of
 Potential Restoration
 2013

Final Array of Potential Restoration Areas

- County Owned Land
- Lower Mile Beach Road w/ Coastal
- Beach Road Raise
- State Owned Land

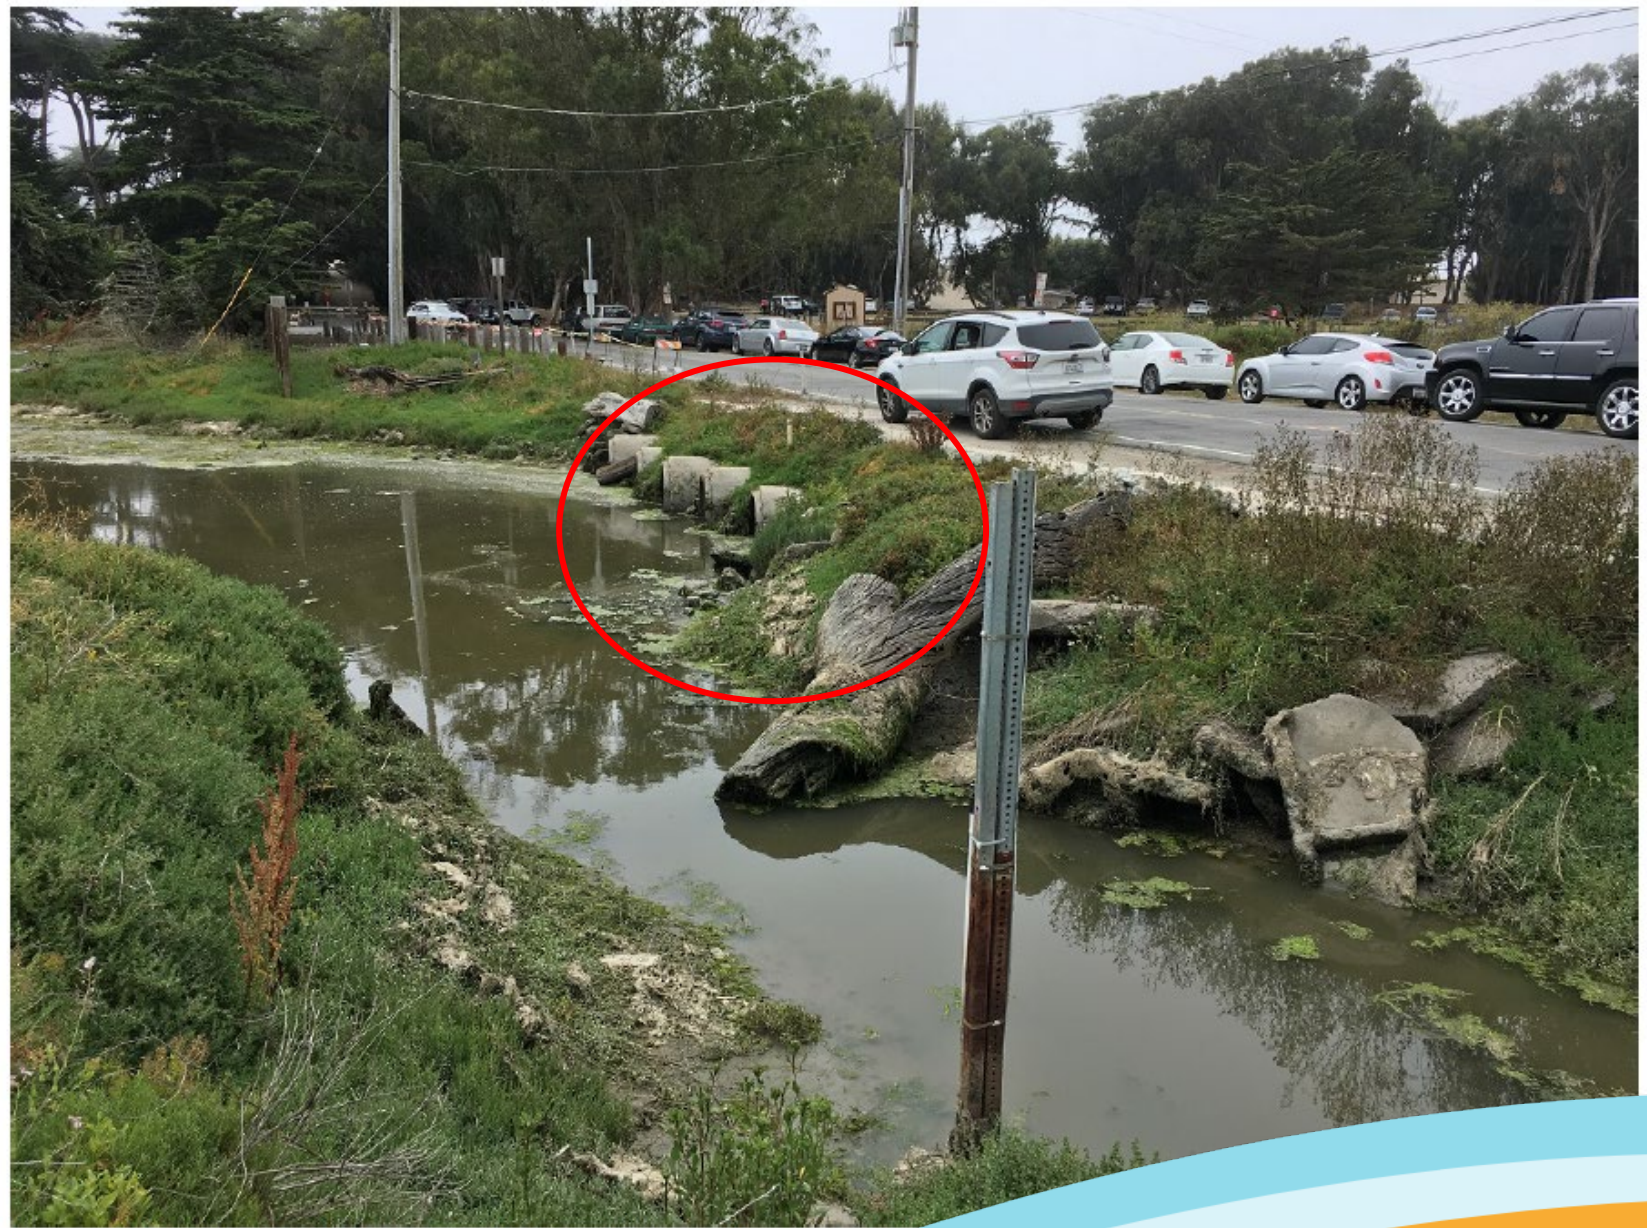
Figure 9. Beach Road Crossing at Watsonville Slough – view of

BEACH ROAD CROSSING

- The Beach Road raise is designed with open-bottom culvert to facilitate fisheries benefits now and in the future.
- The Beach Road raise will change the lagoon breaching threshold from 8ft NAVD to 9.2ft NAVD, allowing higher and longer lagoon closure events that contribute to the natural hydrology of the marsh.
- The change in hydrology will return 2.7 acres of the 4.8-ac County Parcel that had been “high and dry” to marsh hydrology, affecting 56% of parcel. It will return 5.5 acres of the 13.4-ac State Parks parcel from “high and dry” to marsh hydrology, affecting 40% of parcel.
- Exotic and xeric plants will be removed from the marsh plain and the formerly “high and dry” areas will be planted with native marsh species.

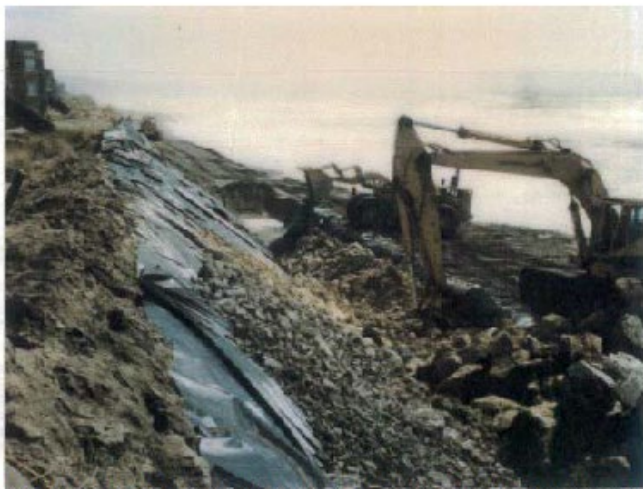
Photograph 1: Pajaro Dunes North Rip-rap Revetment Under Construction in 1983

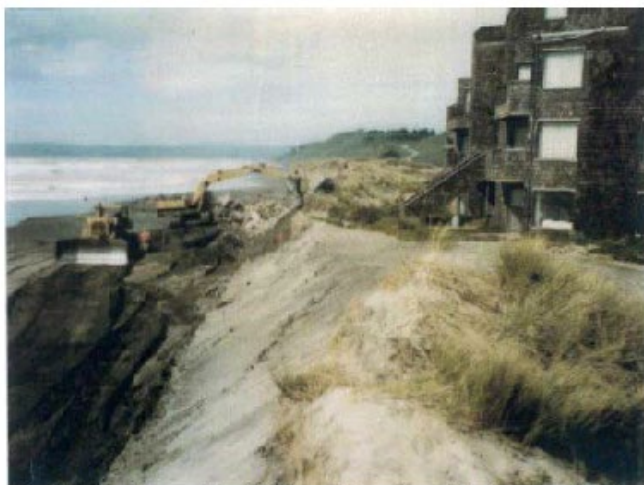
Photograph 2: Pajaro Dunes North Rip-rap Revetment Under Construction in 1983

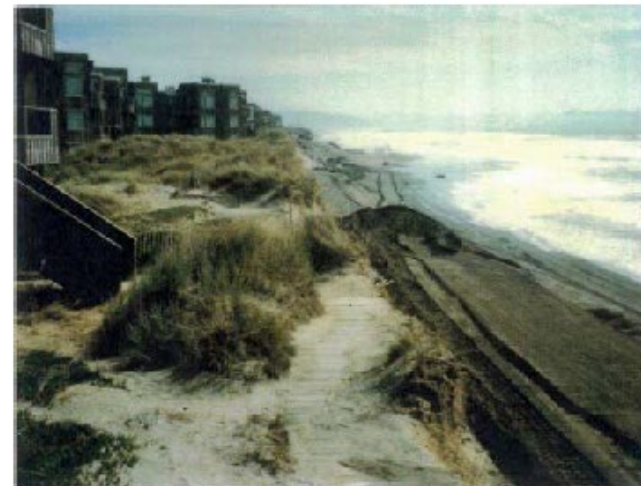
Photograph 3: Pajaro Dunes North Rip-rap Revetment Under Construction in 1983

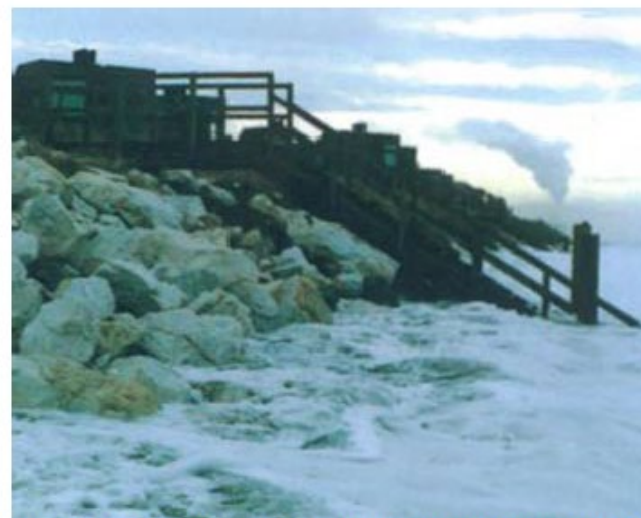
Photograph 4: Pajaro Dunes North Rip-rap Revetment and Stairway Under Wave Impact after Construction in 1983

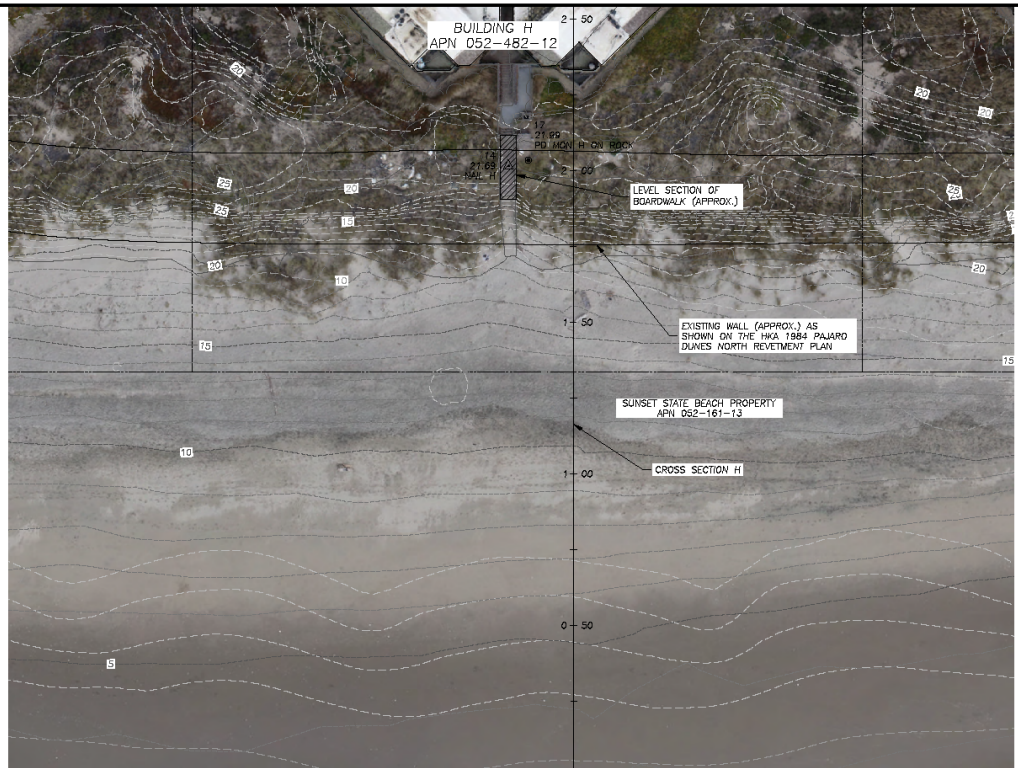
BUILDING H SITE PLAN
SCALE: 1" = 20'

- EXISTING CONTOURS 2021
- EXISTING CONTOURS 1999
- PROPERTY LINE (APPROX.)
- 21.45 SURVEY CONTROL POINT (PT#, EL NAVD88, DESCR)
- 23.19 ROCK REVETMENT MONUMENT (PT#, EL NAVD88, DESCR)
- PD MON A

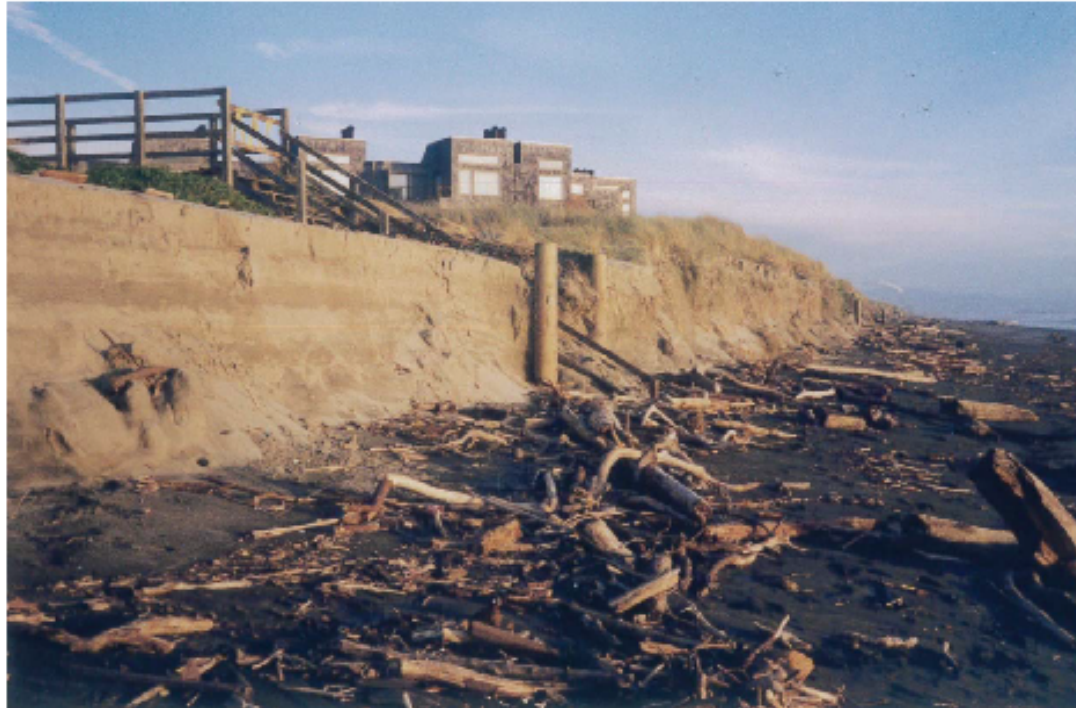
It is more likely that the beach access stairs will be damaged than the revetment, since they extend further seaward than the revetment and thus are more vulnerable. Photos of historical damage are shown below:

Photograph 6: February 12, 1998 Photograph at Building H Stairway

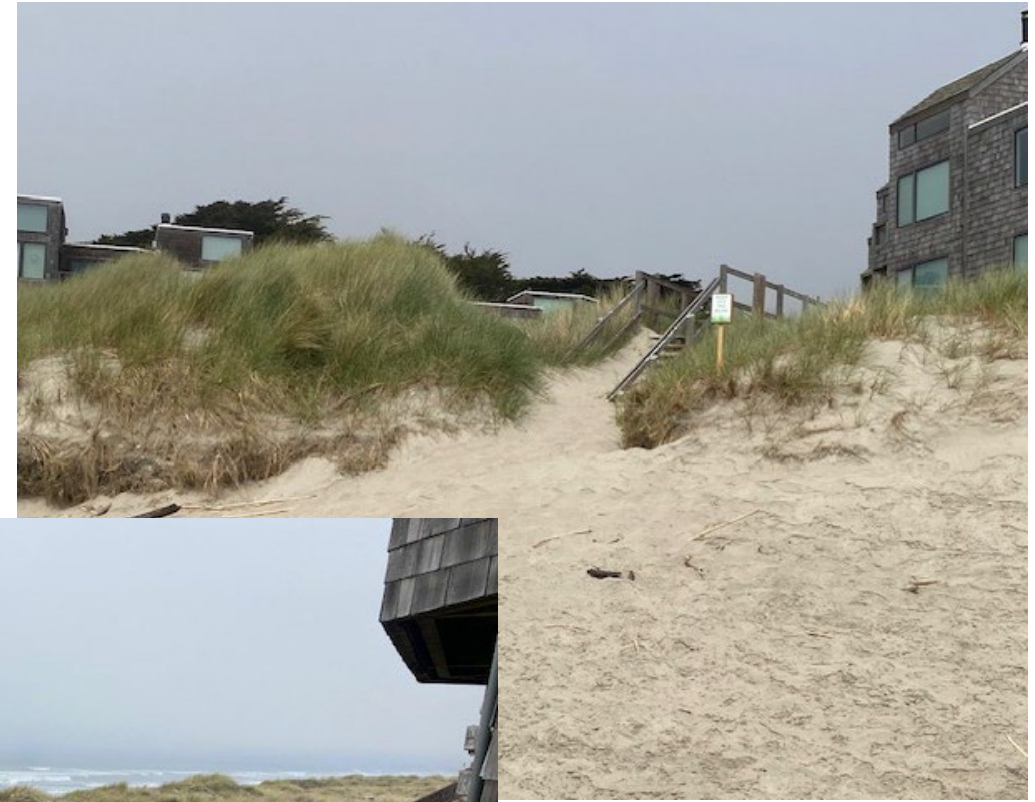
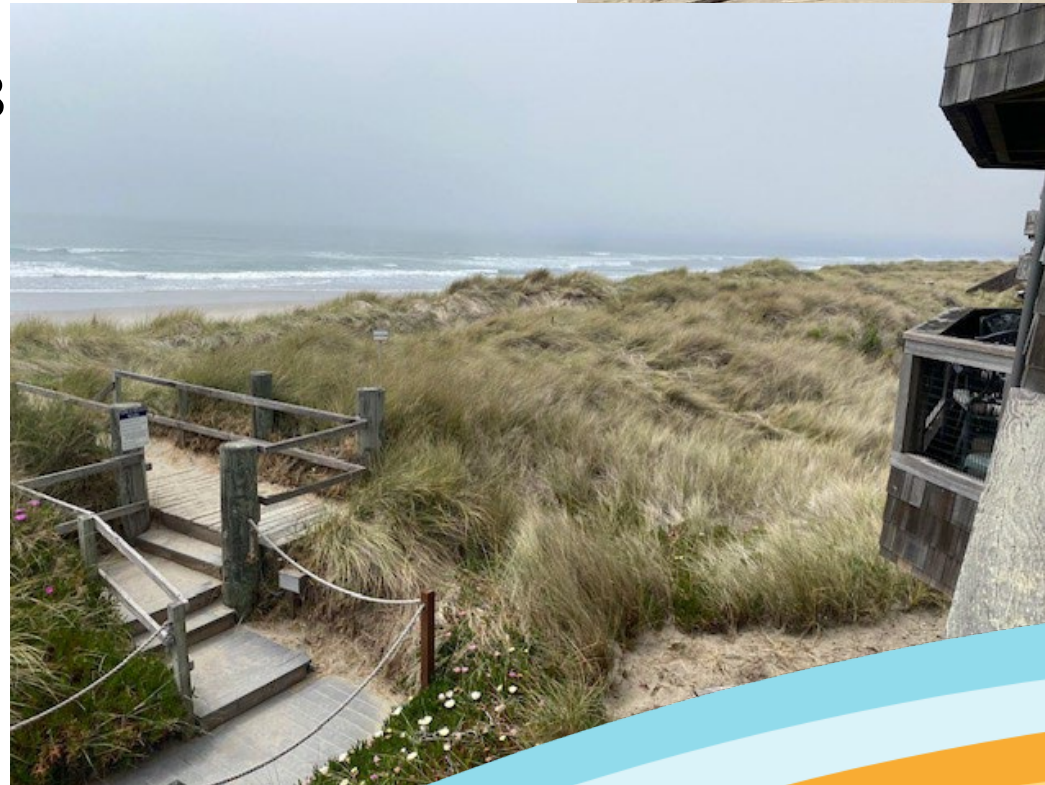
- Net change in sand volume was an increase of 26,882 cubic yards between 1998 and 2021
- Net accretion of 12.13 cy per linear foot of oceanfront
- Annual average of 14.24 cubic feet

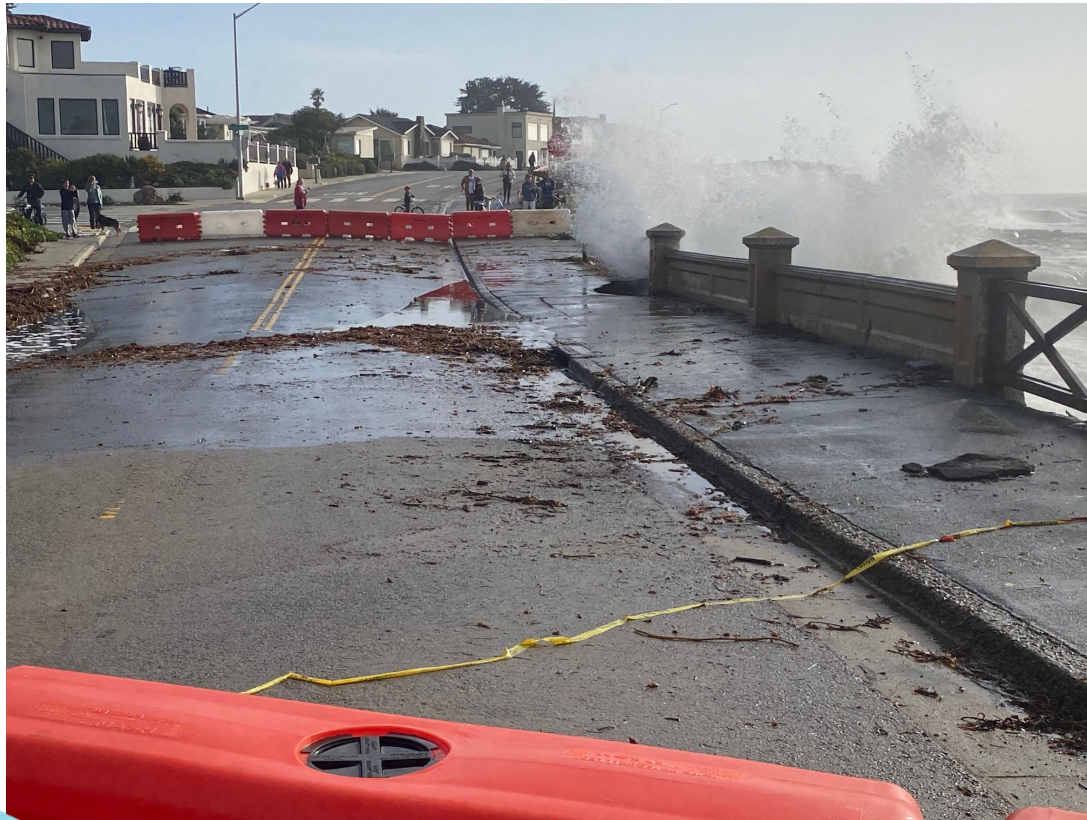
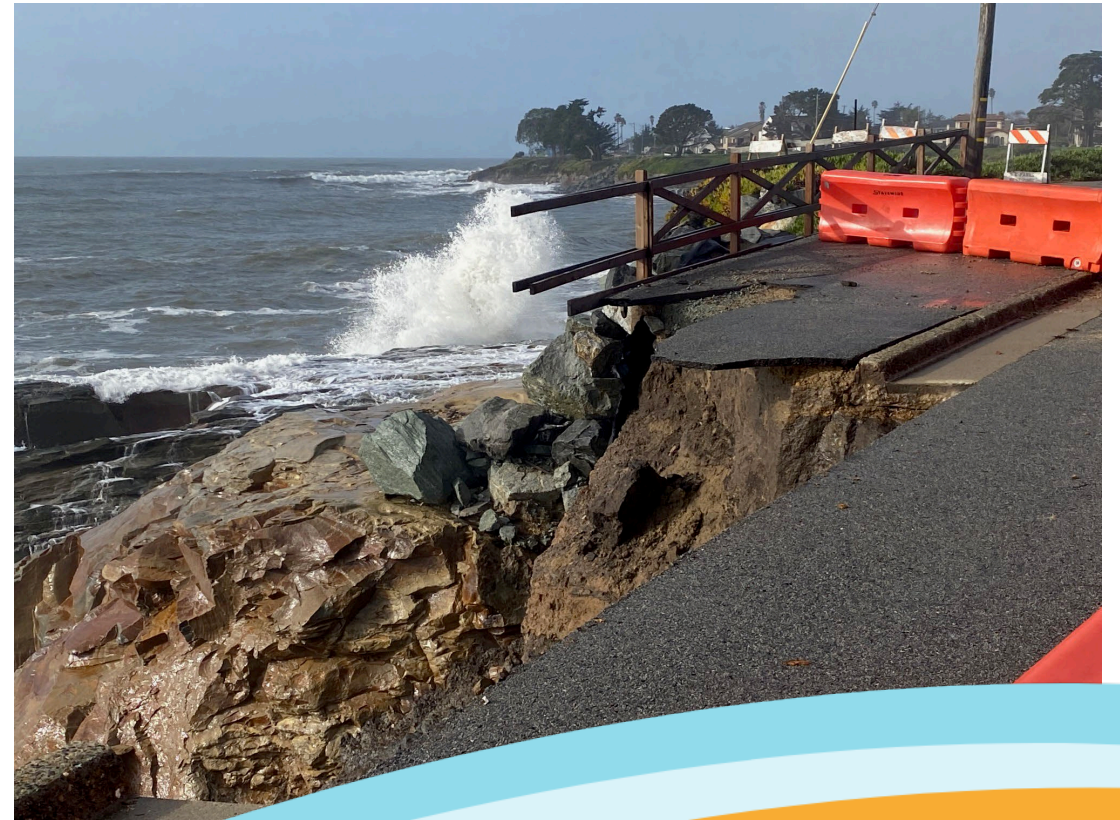
West Cliff Dr. storm damaged area: low point at Woodrow Ave.
